APOLLO 9 MISSION REPORT

MAY 1969

Mission Evaluation Team

George M. Low
Manager, Apollo Spacecraft Program

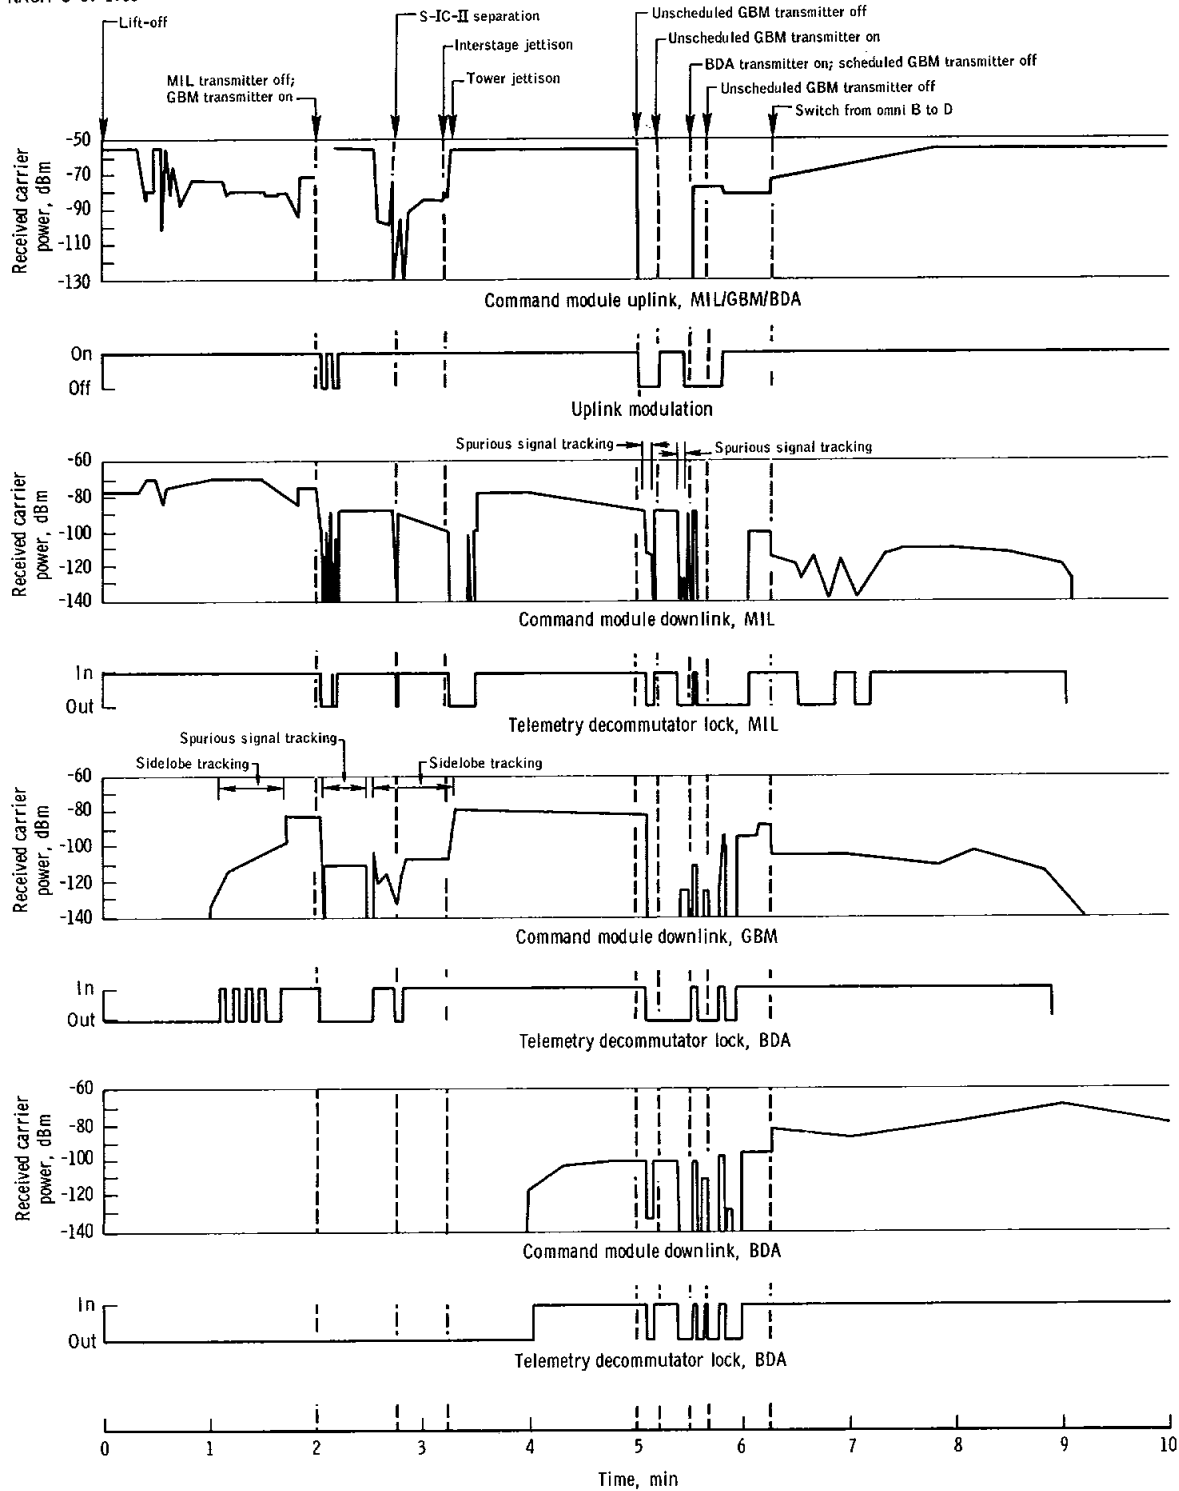
Figure 6-1. - S-band communications during launch.

The first communications problem was a procedural error that occurred during the launch phase. As shown in figure 6-1, procedural errors at the Grand Bahama Island station caused degraded S-band system performance between 0:02:00 and 0:02:32, when the ground receiver locked on to a 51.2-kHz spurious signal in the downlink spectrum, and between 0:02:32 and 0:03:17, when the antenna tracked a sidelobe. A complete loss of S-band communications was encountered between 0:05:01 and 0:06:00 because the operator of the ground transmitter interrupted transmissions 30 seconds early. At 0:05:12, the operator recognized the error and energized the transmitter, but he was unsuccessful in reestablishing two-way phase lock. At 0:05:30 the Bermuda station initiated uplink transmissions as scheduled. The spacecraft transponder immediately locked to the Bermuda signal; however, solid two-way phase lock was not established until 0:06:00. See section 14 for further details.

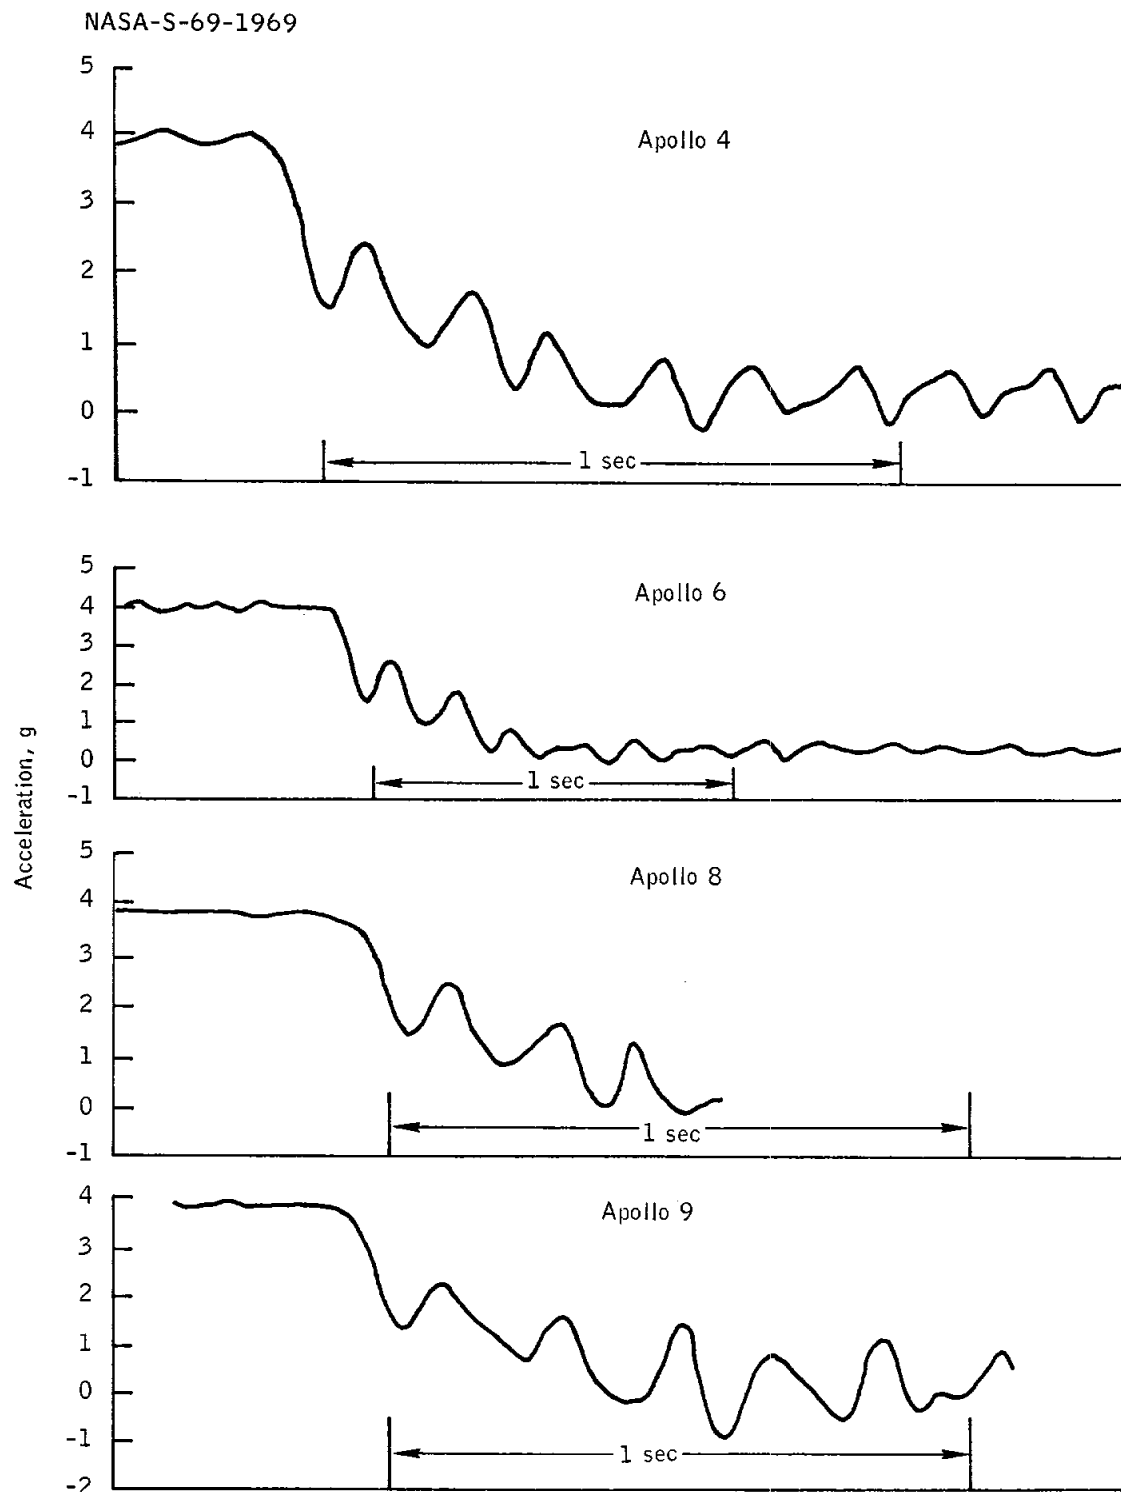
Figure 8.1-1.- Comparison of command module X-axis acceleration at S-IC outboard engine cutoff.

The crew reported experiencing a negative longitudinal acceleration during shutdown and separation of the first stage; the maximum negative acceleration recorded was minus 0.8g at 0:02:43.6. This negative acceleration is greater than any measured in the three previous Saturn V missions (fig. 8.1-1), but it was still less than the design value. This negative acceleration is attributed to a more rapid thrust decay of the first-stage engines from the 30-percent thrust level. The command module accelerations during this period are shown in figure 8.1-2. The measured and predicted maximum tension loads at separation are compared in table 8.1-I.

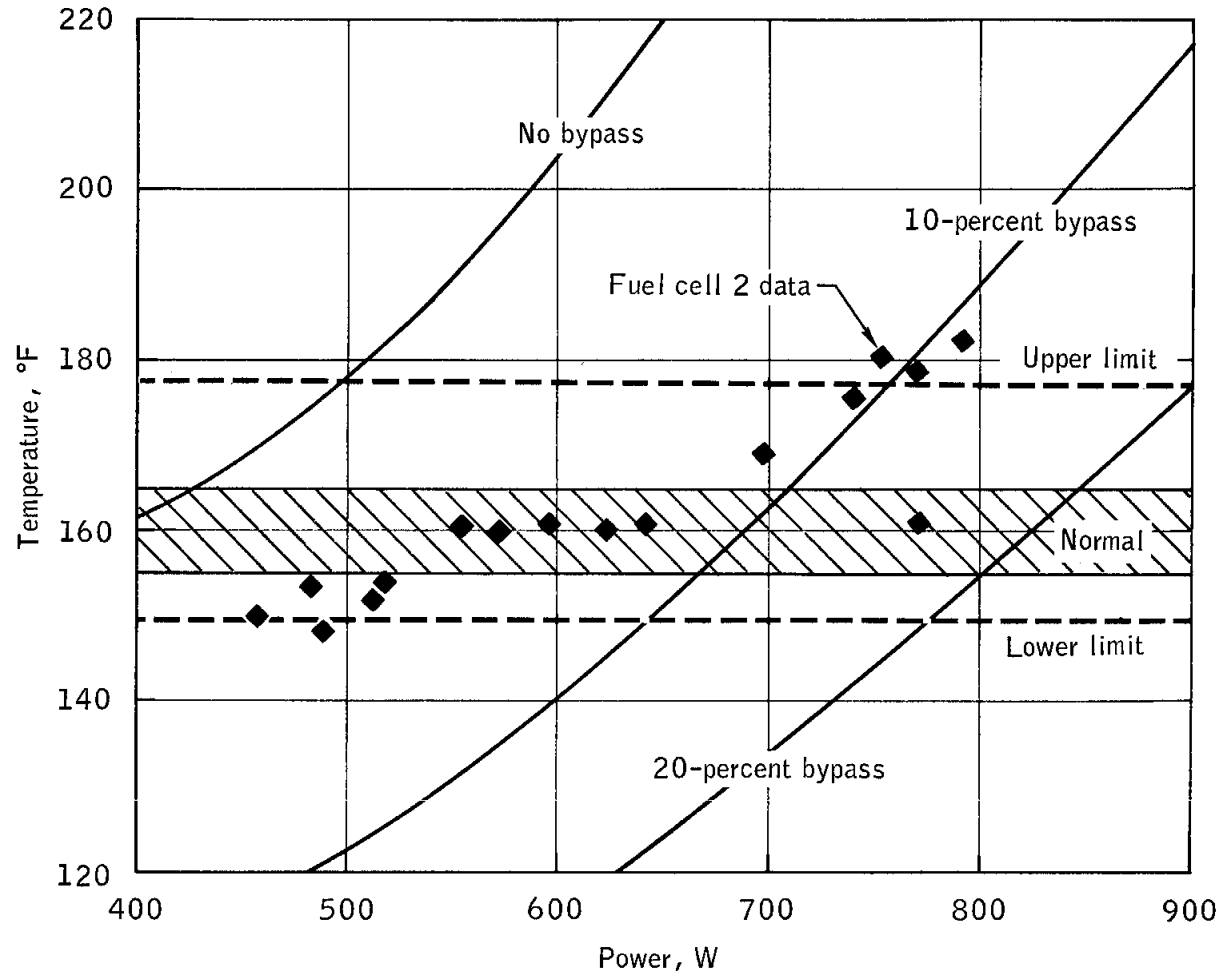
Figure 8.2-1.- Fuel cell 2 condenser exit temperature compared with power output.

The thermal performance under a current load for fuel cells 1 and 3 was within the normal range throughout the flight. The condenser exit temperature for fuel cell 2 was outside the nominal range during power-up and power-down phases between 88 hours to 191 hours, as shown in figure 8.2-1. The minimum condenser exit temperature observed for fuel cell 2 was 148° F at 110 hours with an average current of 15 amperes per fuel cell; the maximum value observed was 184° F at approximately 147 hours with an average current of 27.8 amperes per fuel cell. These and other excursions resulted in low and high caution and warning indications. Fuel cell behavior during this period was very similar to that observed during Apollo 7. The valve travel in the secondary coolant regenerator bypass was restricted between approximately 4 percent and 10 percent bypass during the period from 88 to 191 hours; however, modulation was achieved between these points (fig. 8.2-1). Fuel cell 2 condenser exit temperature returned to normal operating limits after 191 hours under relatively high current conditions. The corresponding bypass valve modulation was normal, between 8 and 19 percent. Section 17 contains a detailed discussion of this anomaly.

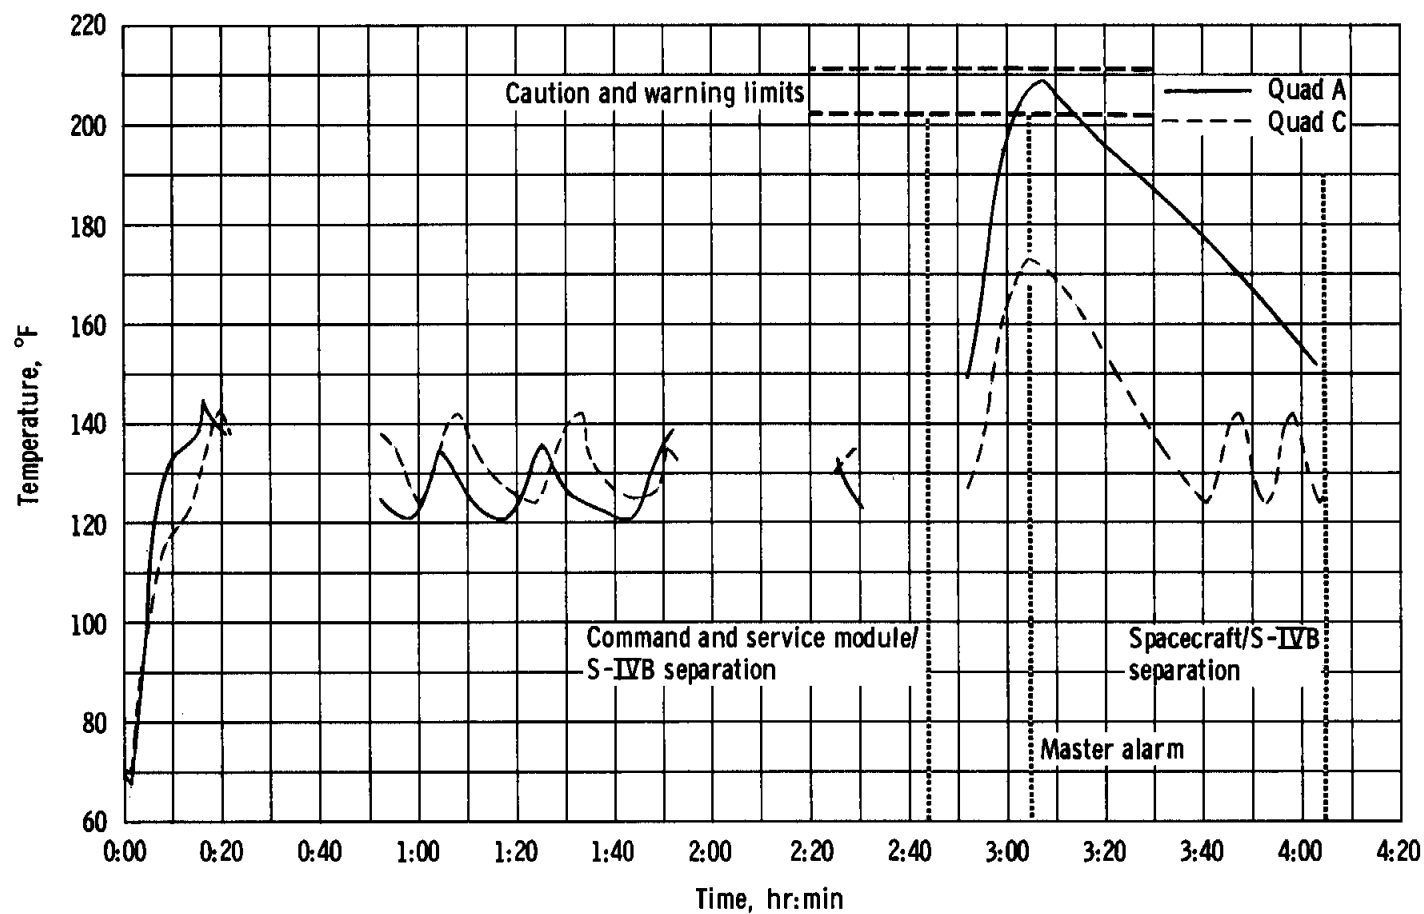
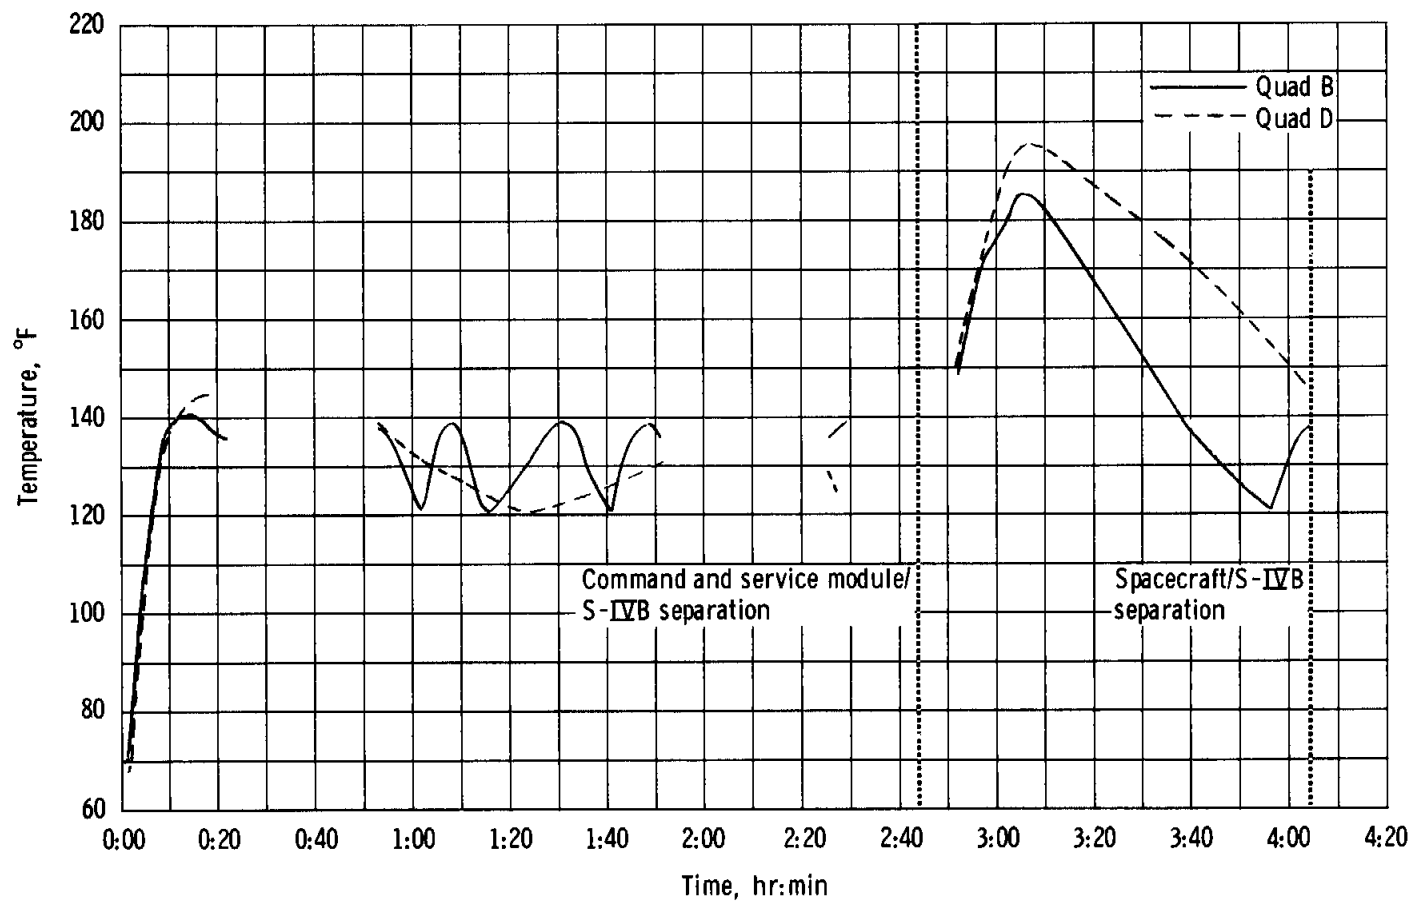
Figure 8.7-1. - Comparison of quad package temperatures from launch through spacecraft separation.

During the time that the quad C isolation valves were closed, high thruster activity was required from quad A. This resulted in a high package temperature on quad A which consequently triggered the caution and warning light. However, as shown in figure 8.7-1, the upper temperature limit of 210° F was not reached. During times of lesser thruster activity, the primary quad heaters maintained the package temperatures between 119° and 141° F.

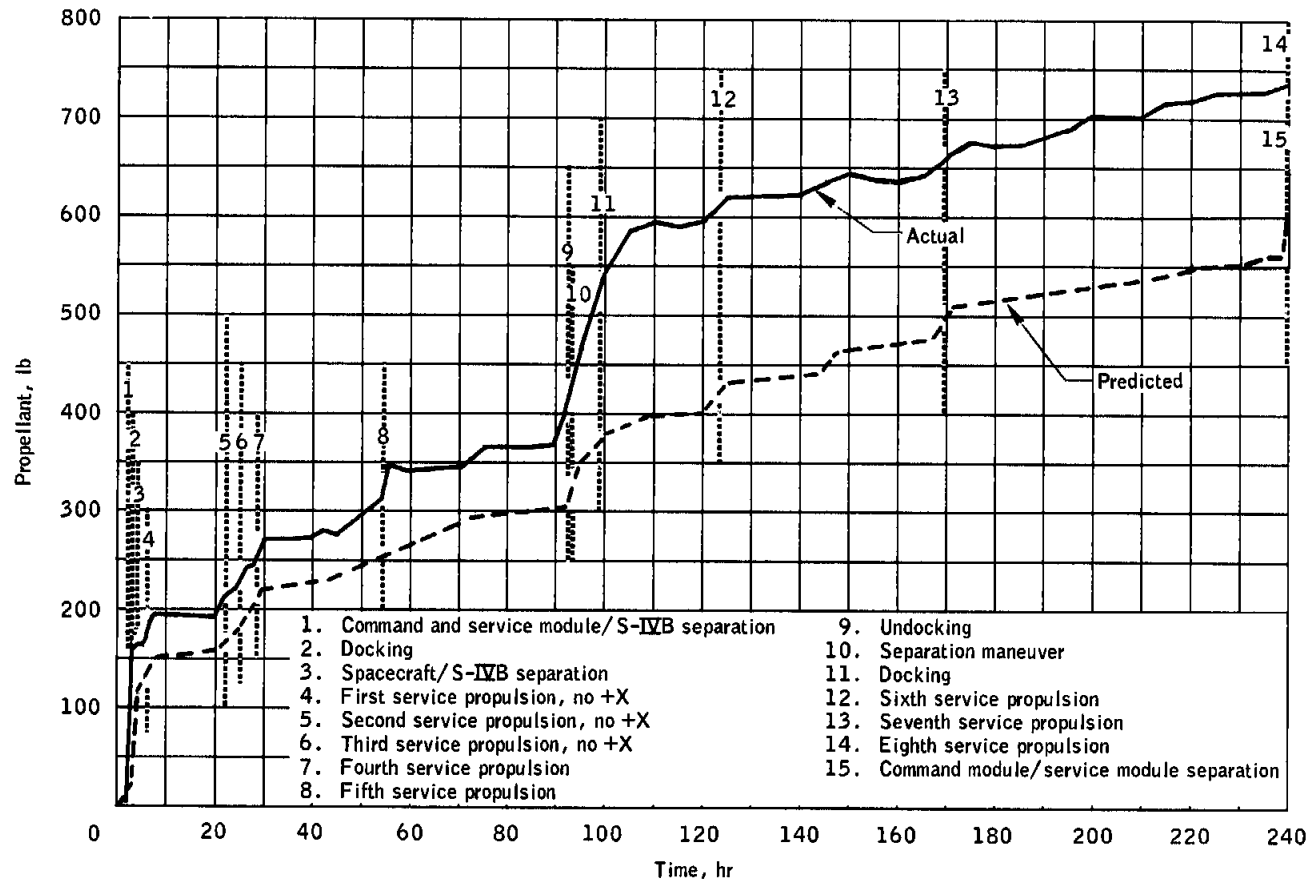
Figure 8.7-2.- Service module reaction control system propellant consumption.

A total of 790 pounds of propellant was used. The actual consumption for all quads is compared with the preflight predicted values, as corrected for flight plan changes, in figure 8.7-2. The total propellant consumption was 192 pounds more than predicted, partly because of the quad C isolation valves being closed but largely because of the exclusive use of the autopilot, rather than the minimum impulse mode, as indicated in section 5.3.2, during the rendezvous. With these exceptions, the actual usage rates approximated the predicted usage. A comparison of ground calculations of propellant remaining with the onboard gage readings is shown in figure 8.7-3. The telemetered gage readings have been corrected for end-point-error and converted from percent remaining to weight of propellant expended.

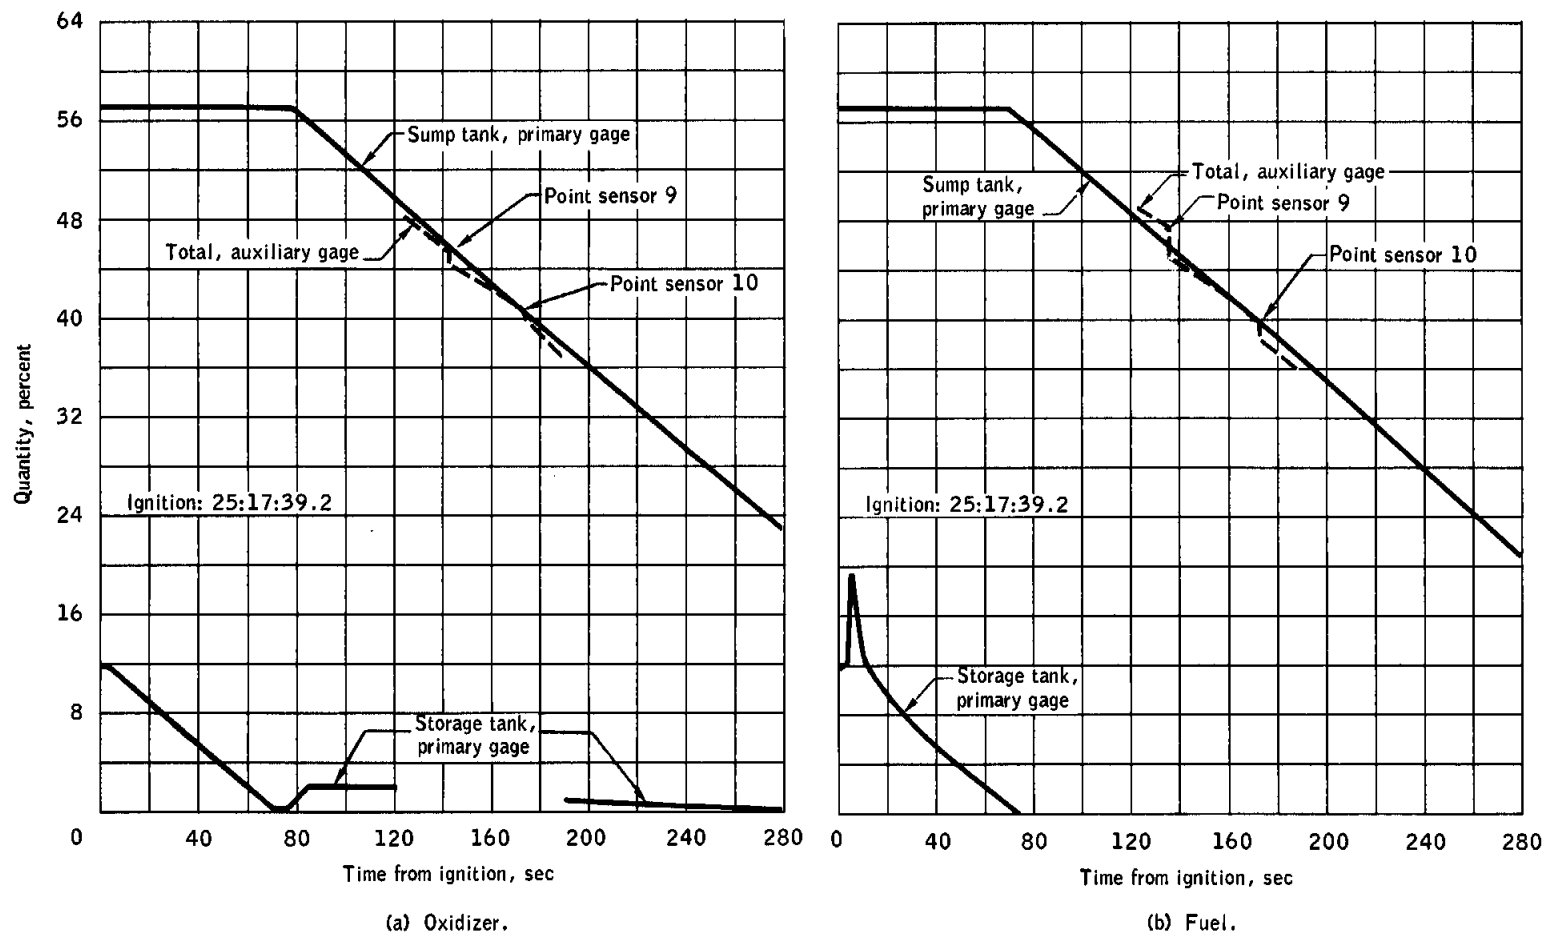
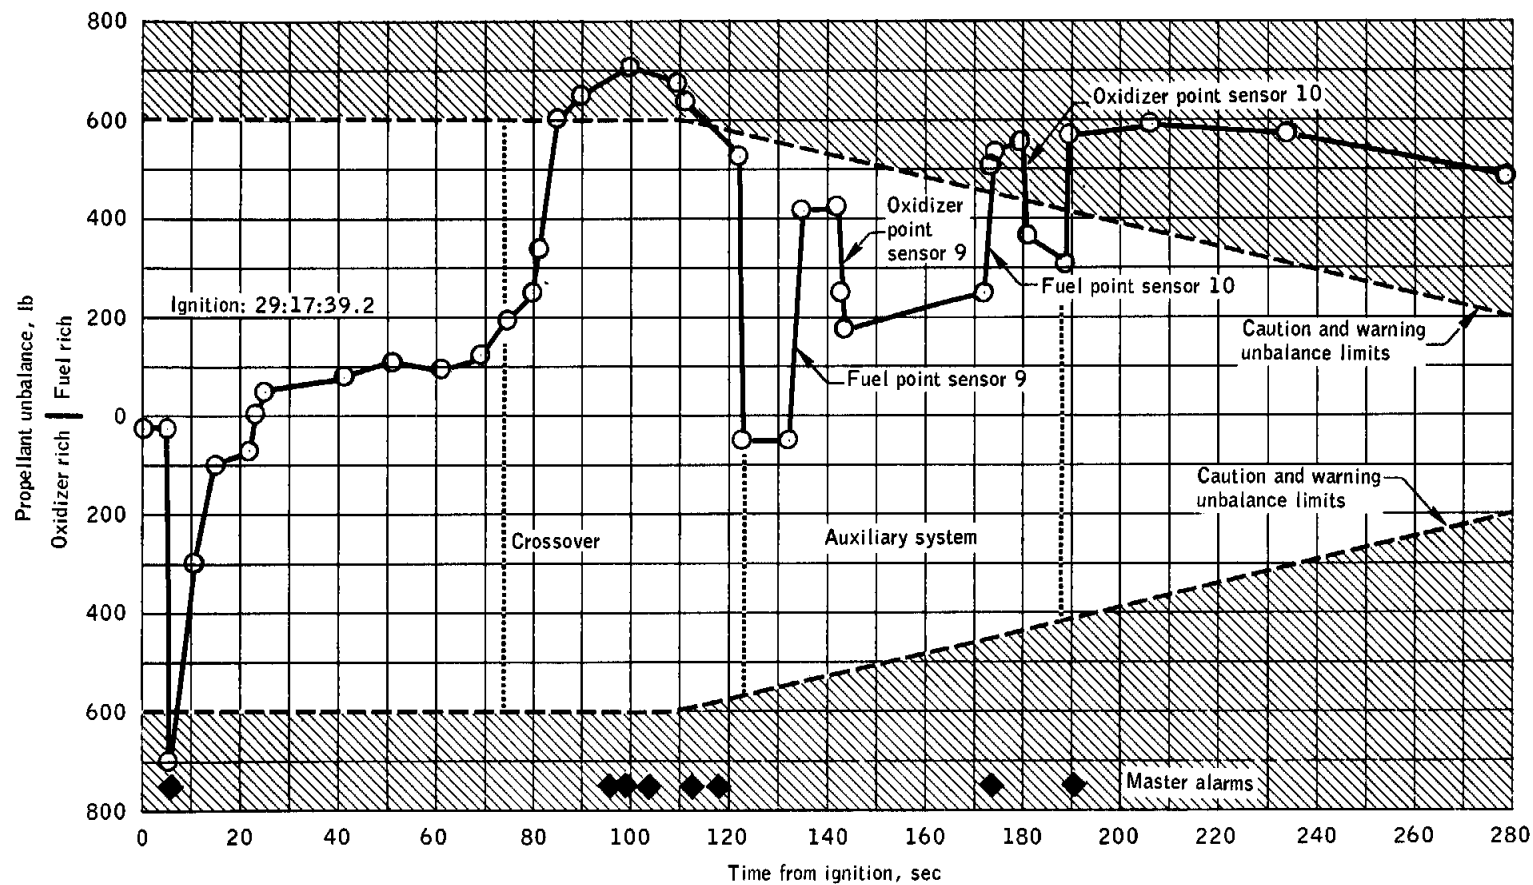
Figure 8.8-1.- Telemetered gaging quantities during third service propulsion firing.

Figure 8.8-1 shows the telemetered gaging system data for oxidizer and fuel during the third firing and figure 8.8-2 shows the indicated unbalance at selected times, as calculated from these data. The unbalance history should reflect the displayed unbalance history within the telemetry accuracy. Also shown in figure 8.8-2 are the times when a caution and warning light was activated. Additional discussion of gaging system discrepancies is contained in section 17.

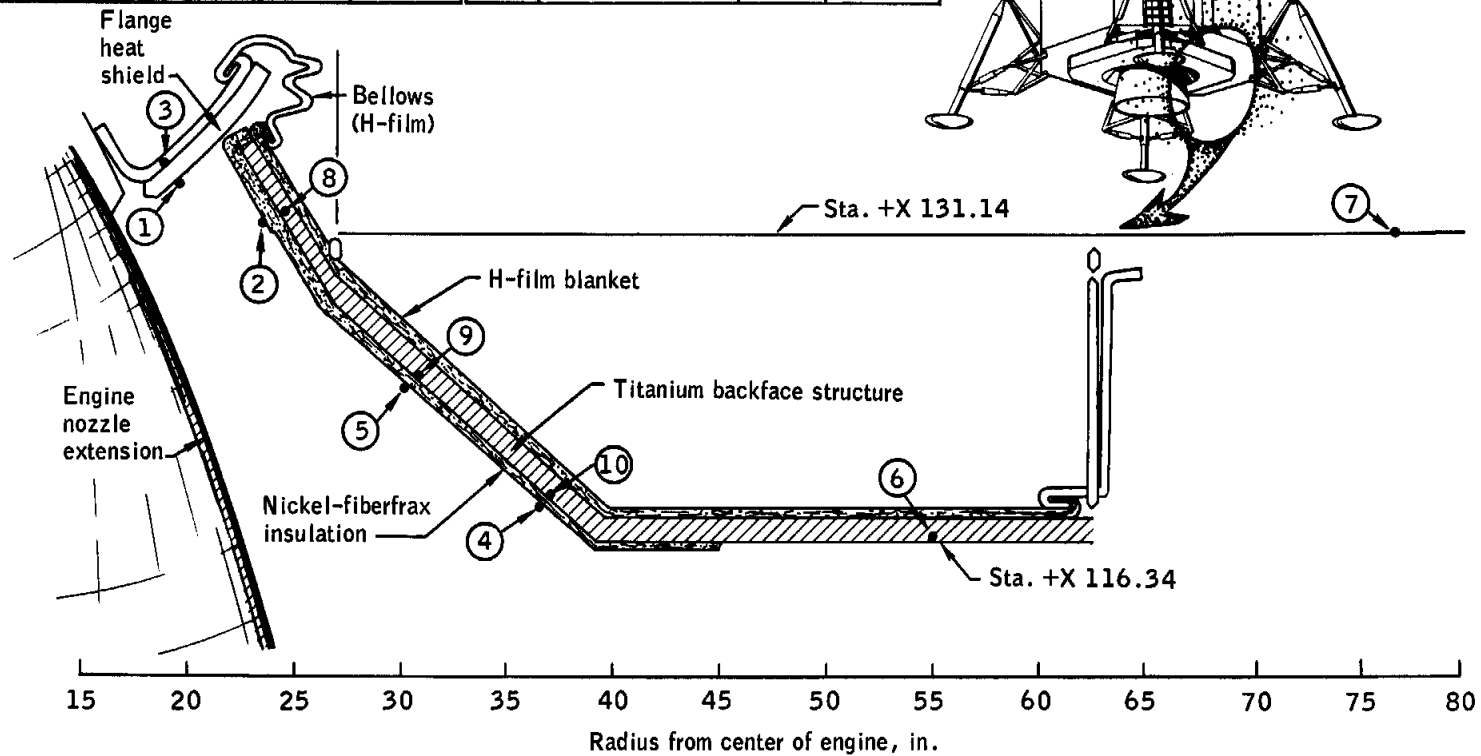
Figure 9.2-2.- Descent stage base heat shield sensor locations and peak temperature.

The temperature response of the descent stage base heat shield was slightly lower than predicted. A comparison of peak temperature, predicted temperature range, and maximum allowable limits is shown in the figure 9.2-2.

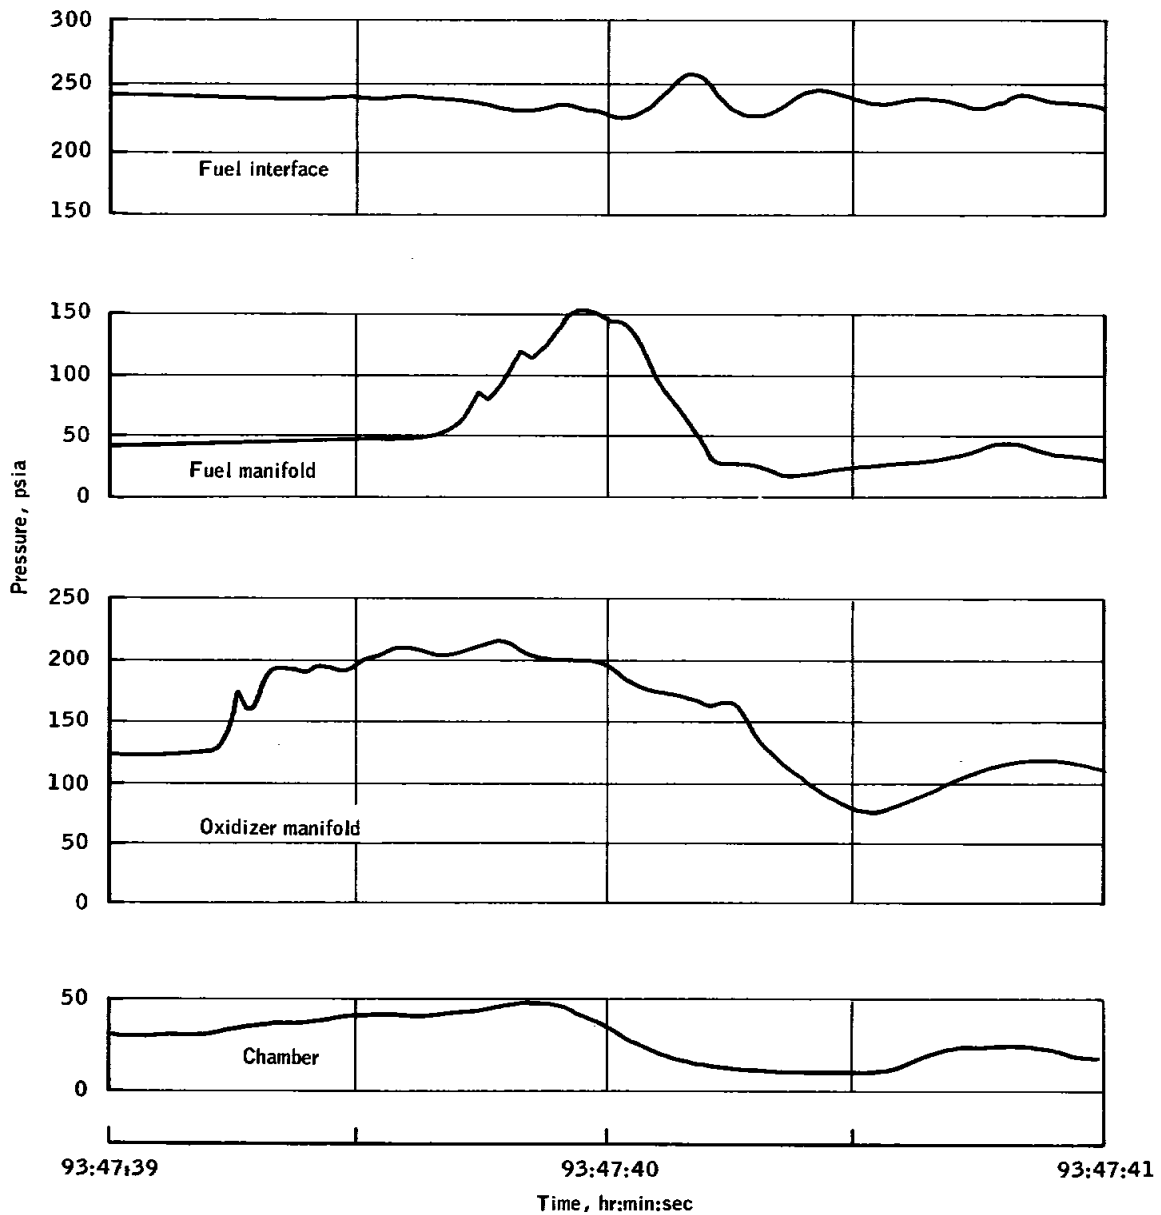
Figure 9.8-2.- Descent propulsion system pressures during second firing (phasing maneuver).

constant until the roughness ceased. This roughness is typical of that experienced with helium ingestion into the combustion chamber. The roughness lasted approximately 2.5 seconds, (see figure 9.8-2) and the remaining portion of the second firing and all of the third firing appeared nominal. See section 17 for further discussion.

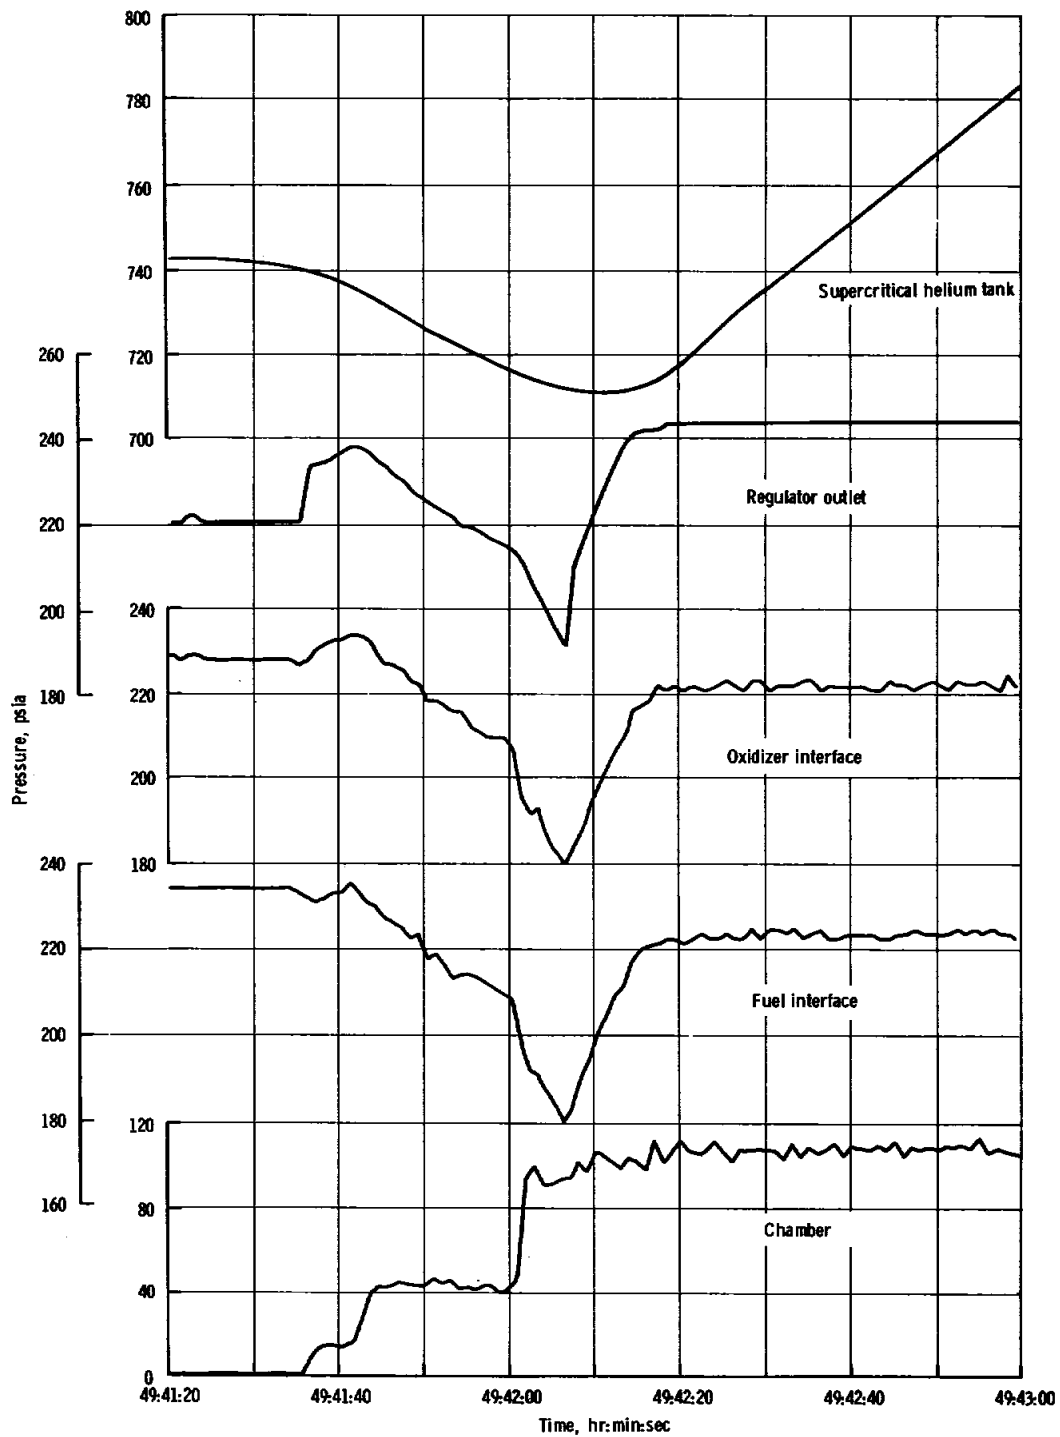
Figure 9.8-3. - Descent propulsion system pressures during start of first firing.

During the first lunar module manning, the helium system pressure was about 743 psia. During the first 33 seconds after engine ignition, the helium bottle pressure decreased to approximately 711 psia (see figure 9.8-3). At the same time, a decrease from 235 to 188 psia in the regulator-outlet manifold pressure was observed. If the system had operated correctly, sufficient helium would have passed through the regulator to maintain a constant regulator-outlet manifold pressure of about 247 psia and the heat transfer through the internal heat exchanger should have increased the pressure in the supercritical helium bottle. The data indicate that the internal heat exchanger was plugged during the initial portion of the firing. See section 17 for further discussion.

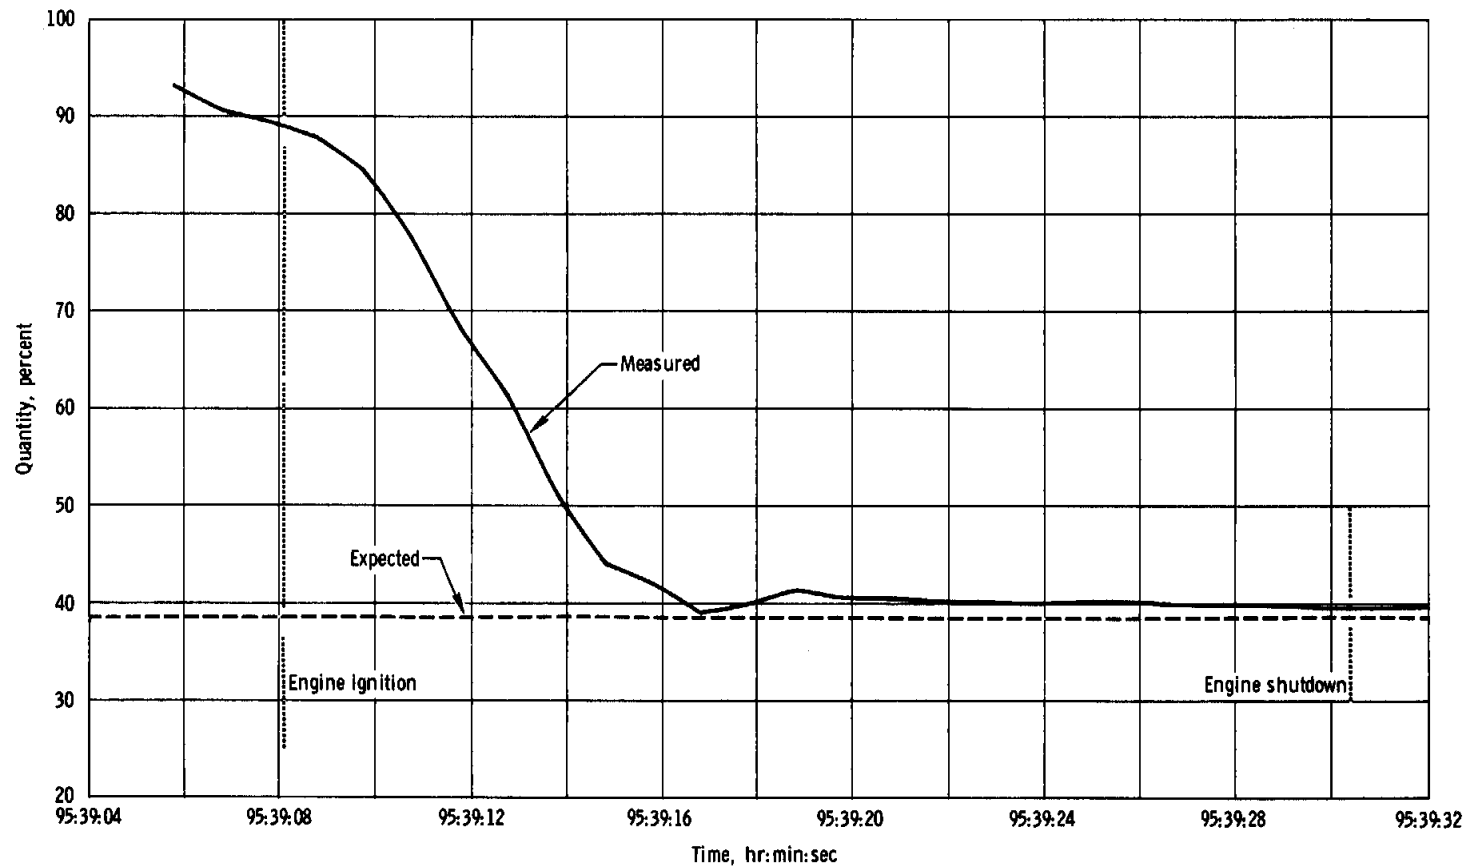
Figure 9.8-4. - Typical descent propulsion quantity gaging system operation (oxidizer tank 1).

service propulsion system gaging system which also used capacitive measuring devices. In general, the displayed quantities were greater than the actual tank quantities (see figure 9.8-4). As the firings continued, the gages tended to stabilize toward correct values. The firing time for the last two maneuvers was too short for the gaging system to completely stabilize.

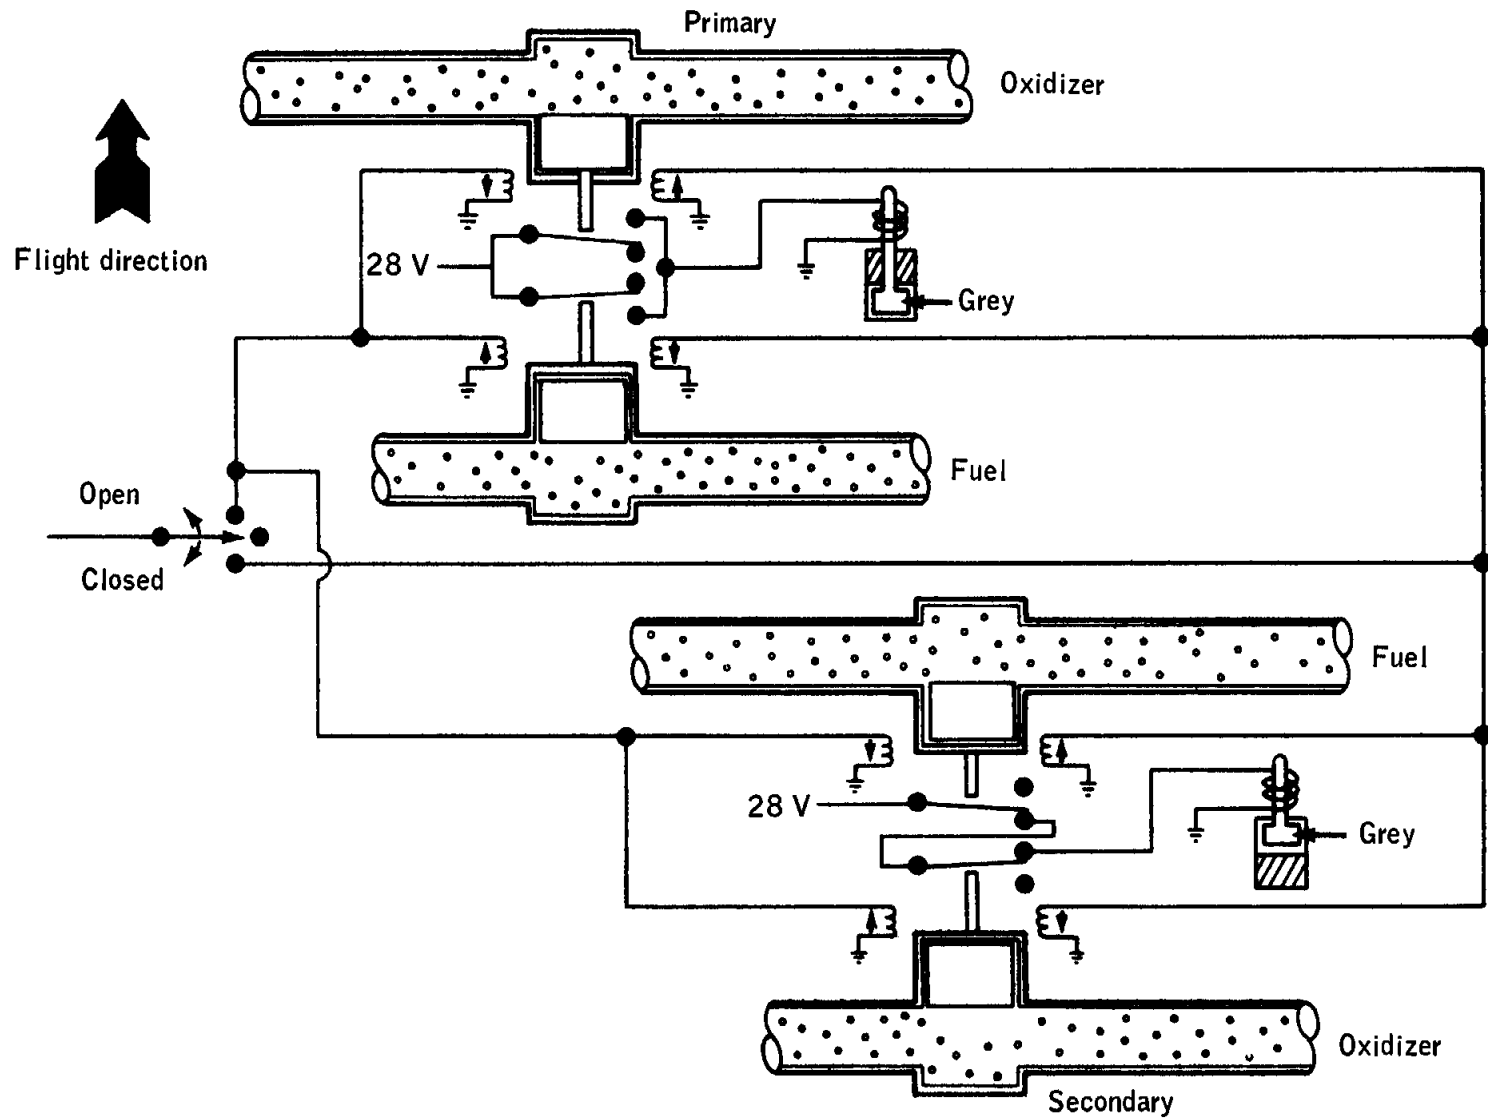
Figure 17-1.- Reaction control isolation valve.

The isolation valve magnetically latches open and is spring-loaded to the closed position. The valves are controlled by momentary switches, located on panel 2, which are spring-loaded to center-off. The four isolation valves in each quad are controlled by one switch (fig. 17-1). The quad C and D switches are adjacent to each other, and normally all four primary and secondary valves are opened or closed simultaneously. The closed indication in quad D for the secondary valves only required that either one or both of the secondary valves be closed, but neither of the primary valves. Tests have demonstrated that it is possible to strike the switch momentarily so that only one of the four valves is closed, but this occurrence has only been demonstrated once in two hundred attempts. Each switch is guarded by a wicket which extends slightly beyond the switch to minimize inadvertent actuation; however, since the switch is spring-loaded to center, inadvertent actuation could go undetected.

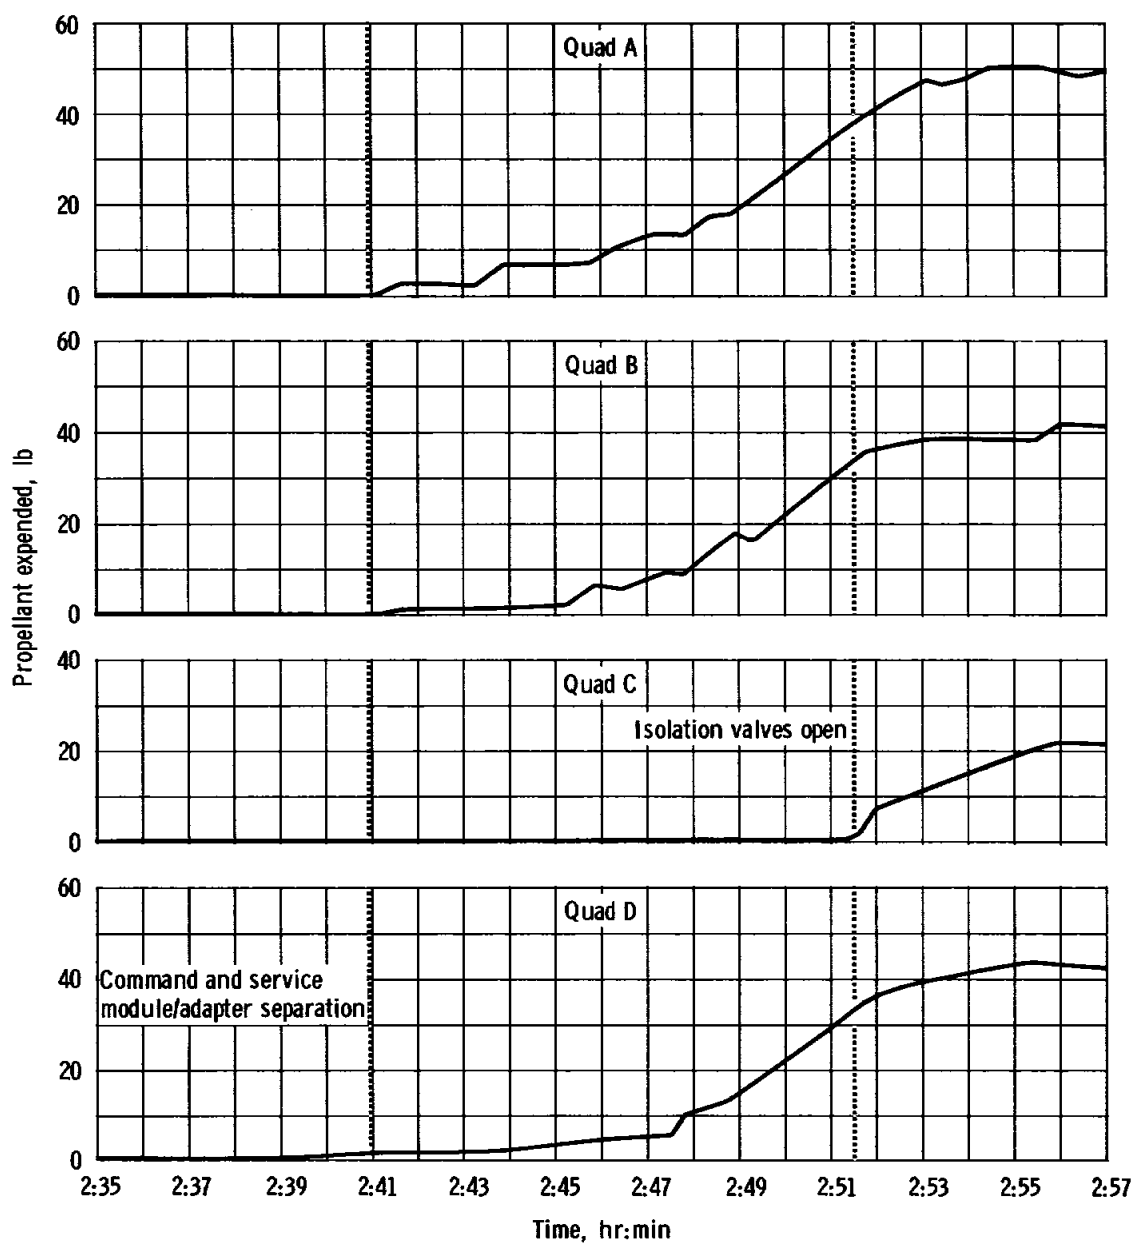
Figure 17-2. - Propellant expended showing inactivity of quad C.

Propellant usage data (fig. 17-2) showed that all four quad C valves were closed and that quad D was performing normally before the crew reopened the propellant isolation valves. Propellant may be supplied from either the primary or secondary tanks, and only the valve indicator for the secondary tank was in the "barber pole" position for quad D. Closure of only one of the secondary valves is sufficient to cause the indication (fig. 17-1).
